Arkema Facility - Harvey Response

Arkema Inc.

September 3, 2017

Project #109489 Summary

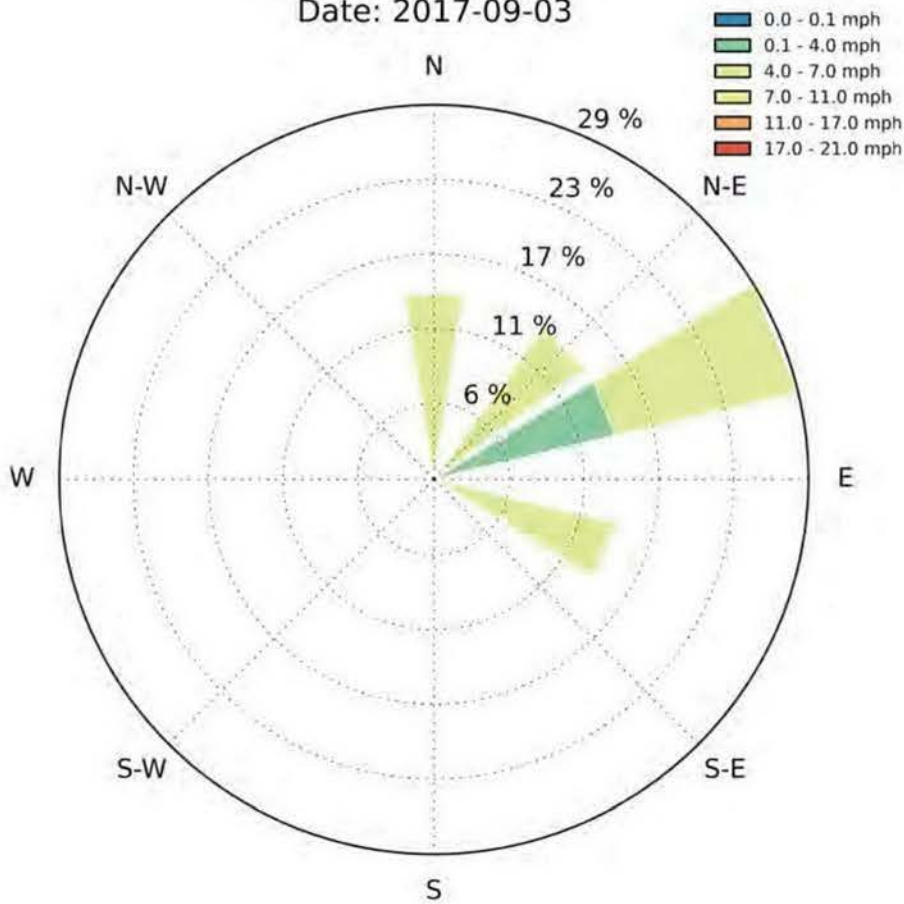
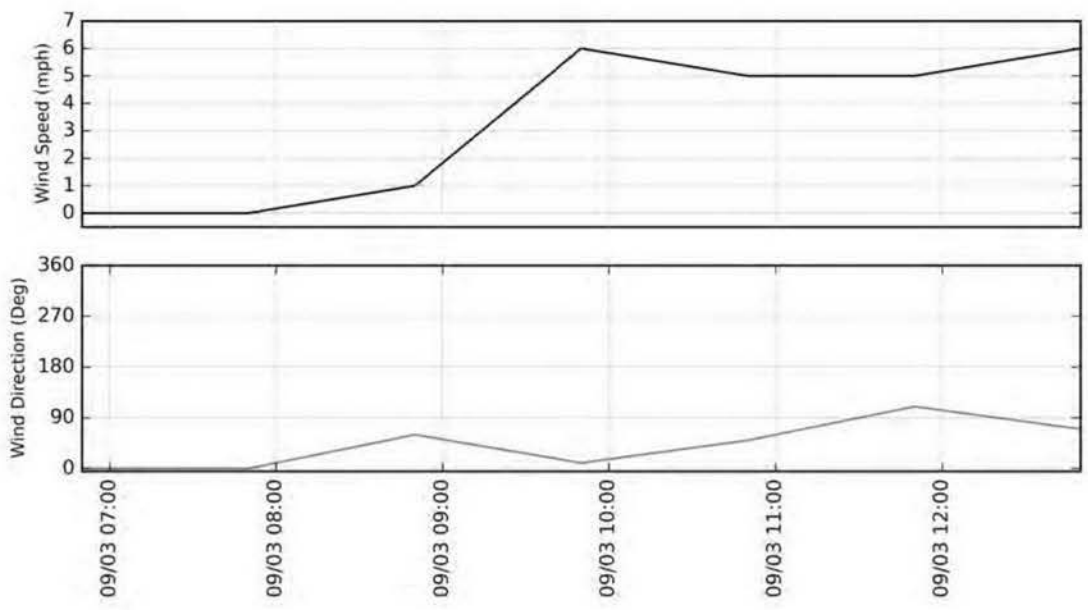
Weather Station: KHPY
Date: 2017-09-03

KHPY Windrose

(Highland Park Airport - 12.5 miles SSE of Site)
